ECO BUILDING SYSTEMS CORP. TEST REPORT

TORNADO IMPACT AND STRUCTURAL WIND LOAD TESTING ON EBS 10 INCH ASYMMETRIC INSULATED COMPOSITE CONCRETE FORM (ICCF) BLOCK WALL SYSTEM

H6867.01-801-44-R0

03/19/18

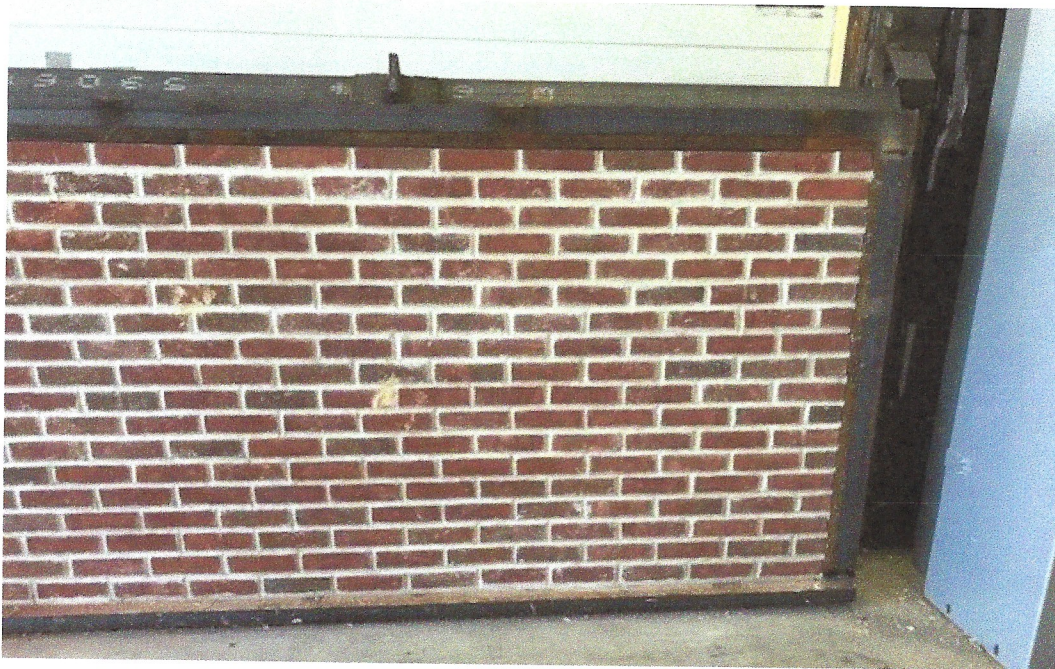
Photo No. 5
Wall system after impacts
