LVT Restoration and
Micron Sealing at K-12
School in South Dakota

LVT from a top 5
Global manufacturer

May, 2021

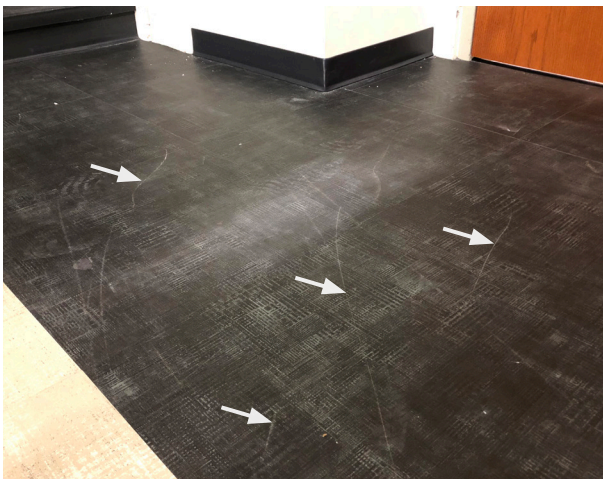
Multi-use room by gym entrance. Many scratches and scuffs visible on the black tile.

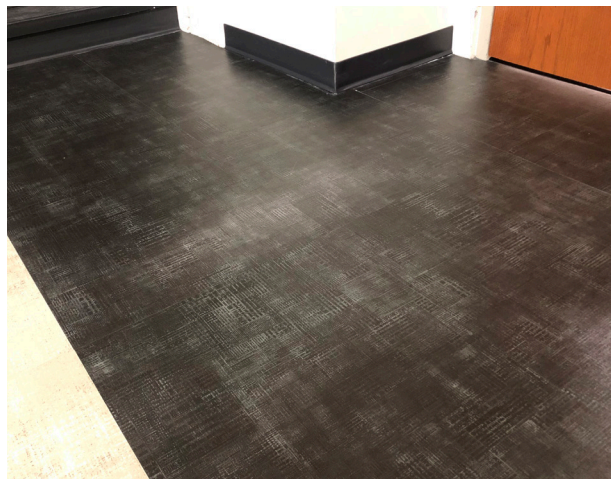
Same area after full treatment.

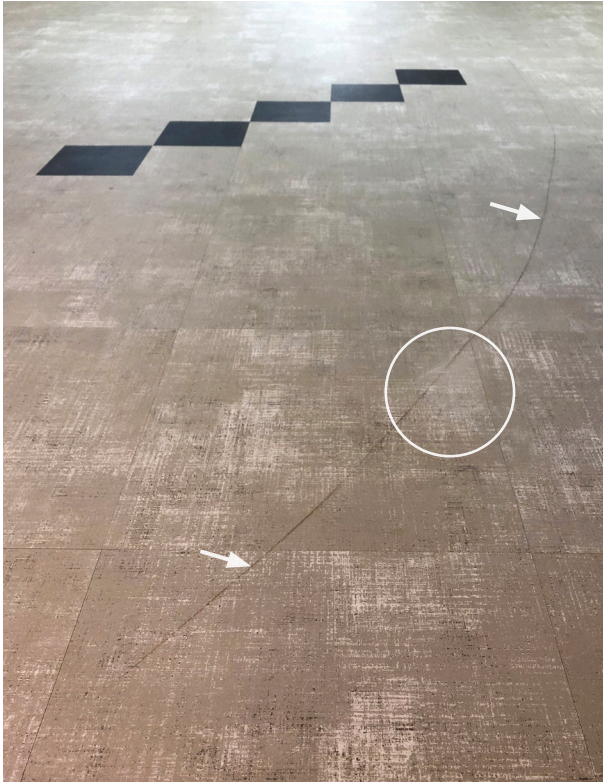
Top of entry lobby with very long arcing dark scuff. Attempts by the school to remove the mark using an abrasive sponge scrub pad resulted in a dulled-out spot (circled).

II. After drying, an inspection took place to evaluate the visible scuff marks and scratches. The scuffs and scratches were largely no longer visible to the naked eye while standing on the floor. Remaining scuffs were gently buffed by hand with water and the Maroon X Restoration Pad. The one long scuff referenced earlier had been significantly removed but a final removal was quickly achieved with a swing machine, the restoration pad and water.

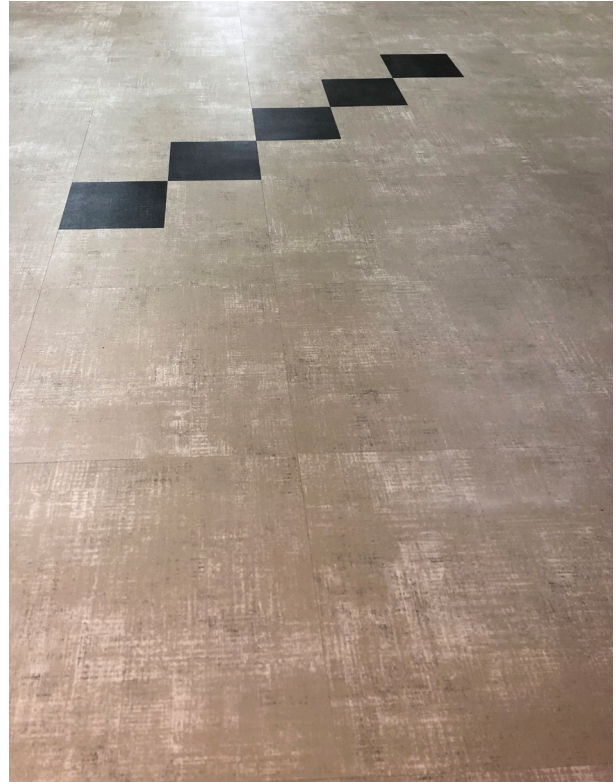
After treatment, the scuff was 100% removed and the dulled area eliminated with no sign of damage.

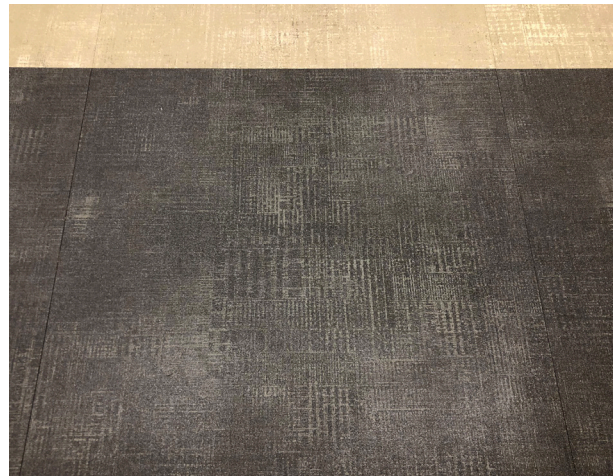
Same tiles after full treatment. Some of the deeper scratches were not removed by this more tempered approach to refurbishment in which case it was recommended to replace those tiles with attic stock and applying Vinyl Seal.

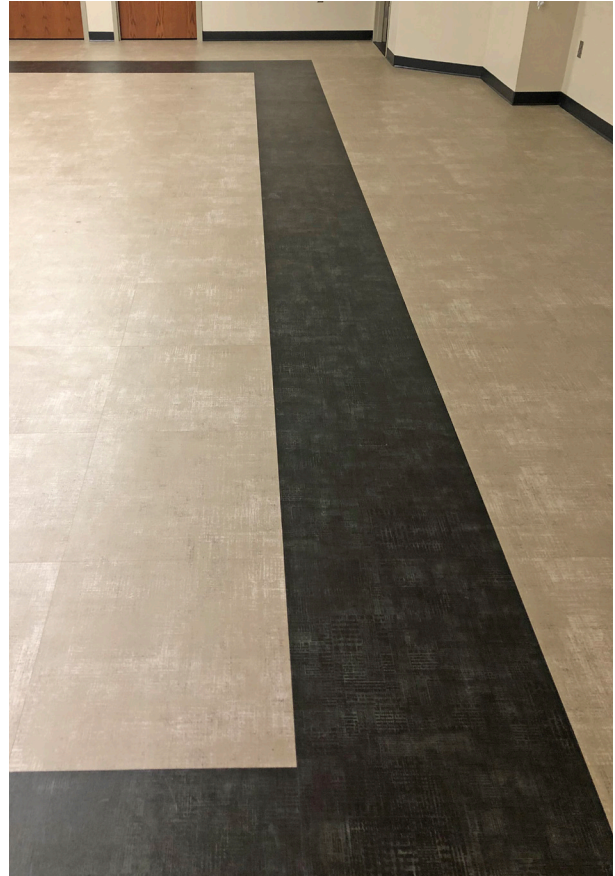
After treatment, scuffs were gone and the appearance of most scratches eliminated. There were deeper scratches that we attempted to repair with the restoration pad by hand. We were not successful and suggested replacing these tiles with attic stock.

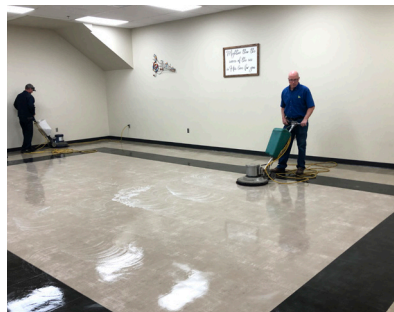
Cleaning the science lab.

I. The floor was cleaned by wet scrubbing using standard 175 rpm swing machines and a Maroon X Restoration Pad. The pad was flipped every 500 sq. feet. NeverStrip Deep Clean was used at 4 oz./gallon of water. The cleaner solution resided on the floor for 10 minute prior to scrubbing. The scrubbing goals were 1) to deep clean the floor; 2) remove/reduce a large percentage of scuffs, marks and stains and 3) buff out or reduce the visibility of surface scratches on the UV cured urethane applied in the factory.

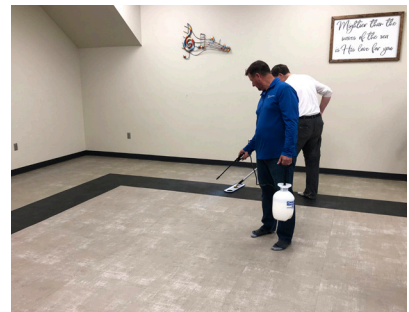
Applying the Vinyl Seal.

III. The first application of Vinyl Seal was applied using a microfiber pad, with one person spraying the Vinyl Seal on the floor in four tile sections using a small nozzle bottle, while the other spread the Vinyl Seal on the floor tiles. The motion was gentle but brisk as the Vinyl Seal dries quickly, particularly in low humidity environments.

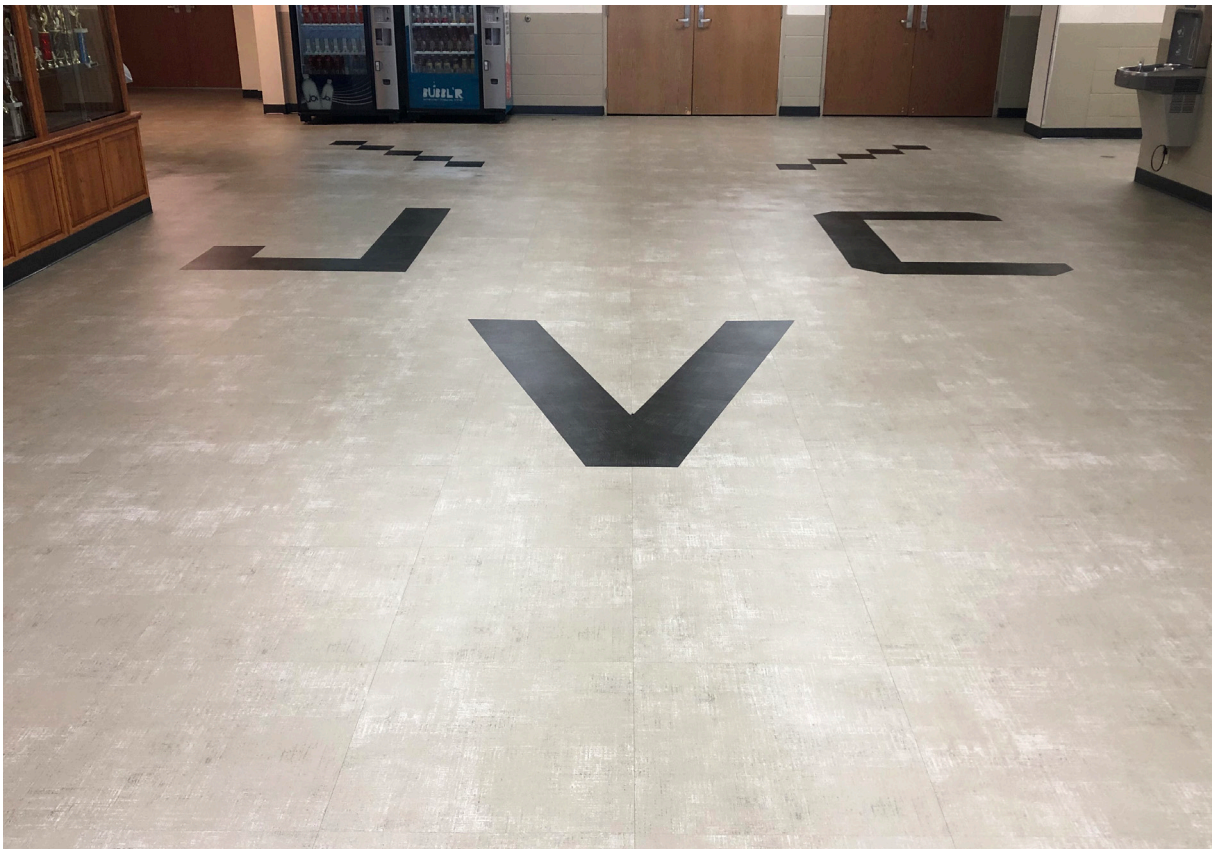
Front entry lobby after treatment. The long dark scuffs in early photos were at the top and left side of this space.
