RESIDENTIAL REPORT

499 Hidden Hills Dr Winchester KY 40391

Mark Beauchamp JANUARY 4, 2021

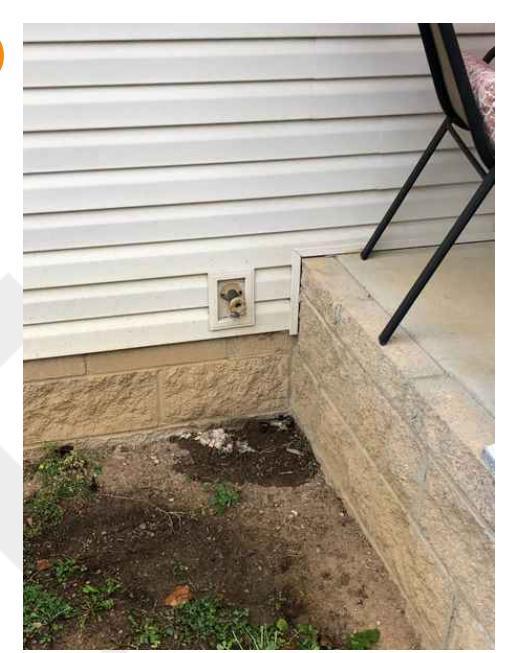
2.1.1 Grading/Drainage INSUFFICIENT GRADING

The current configuration of the grading will not allow rainwater to run away from the structure properly in the referenced area(s) or portions of the referenced area(s). Grading is either wrong or right, with no gray areas in between. The grading either slopes away from the structure (Right-Positive Grading), is at (Wrong), or slopes towards the structure (Wrong-Negative Grade). Even though no repercussions may be present at the time of inspection due to improper grading, the possibility of moisture infiltration through foundation walls is always possible during heavy rainfall events.

Flat grading and negative grading allows the soil in these areas to become saturated, once saturated the porous, permeable masonry foundation walls can wick this water out of the soil via capillary action. This can allow the masonry itself to become saturated and either evaporate this moisture into areas below grade in the form of water vapor, creating high humidity, or allow for moisture or water infiltration into areas below grade.

As mentioned in the "Grading / Drainage Information" comment above, the soil is recommended to slope away from the structure, with a 6 inch drop in elevation, in the first 10 feet away (5% grade). When the proper grade can not be achieved a swale or drain should be installed as needed to manage rainwater runoff. An evaluation of the grading around the home with repairs made as needed to allow for the proper runoff of rainwater is recommended to be conducted by a grading contractor, foundation contractor, or other qualified contractor.

Recommendation Contact a qualified grading contractor.

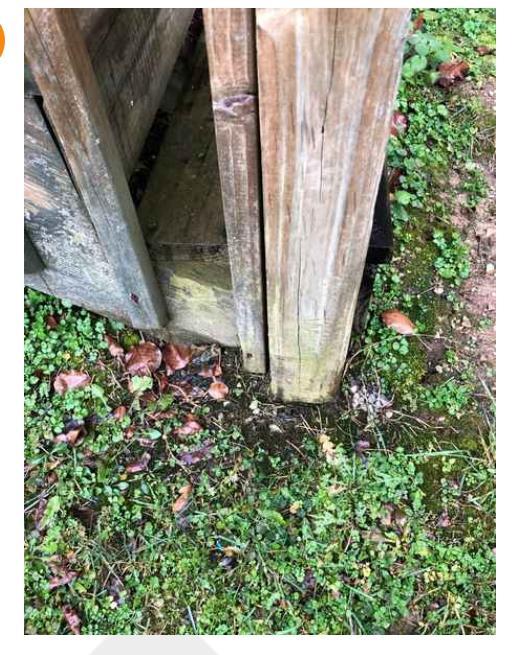
3.3.2 Decks, Balconies, Porches & Steps

POST CHECKING AND ROTATION, SEPARATION

The effective age of the rear deck is nearing the end of its useful life. Through age there is splitting, rotation, and separation in various areas of decking. While currently still safe there should be efforts made to make replacement.

Recommendation Contact a qualified professional.

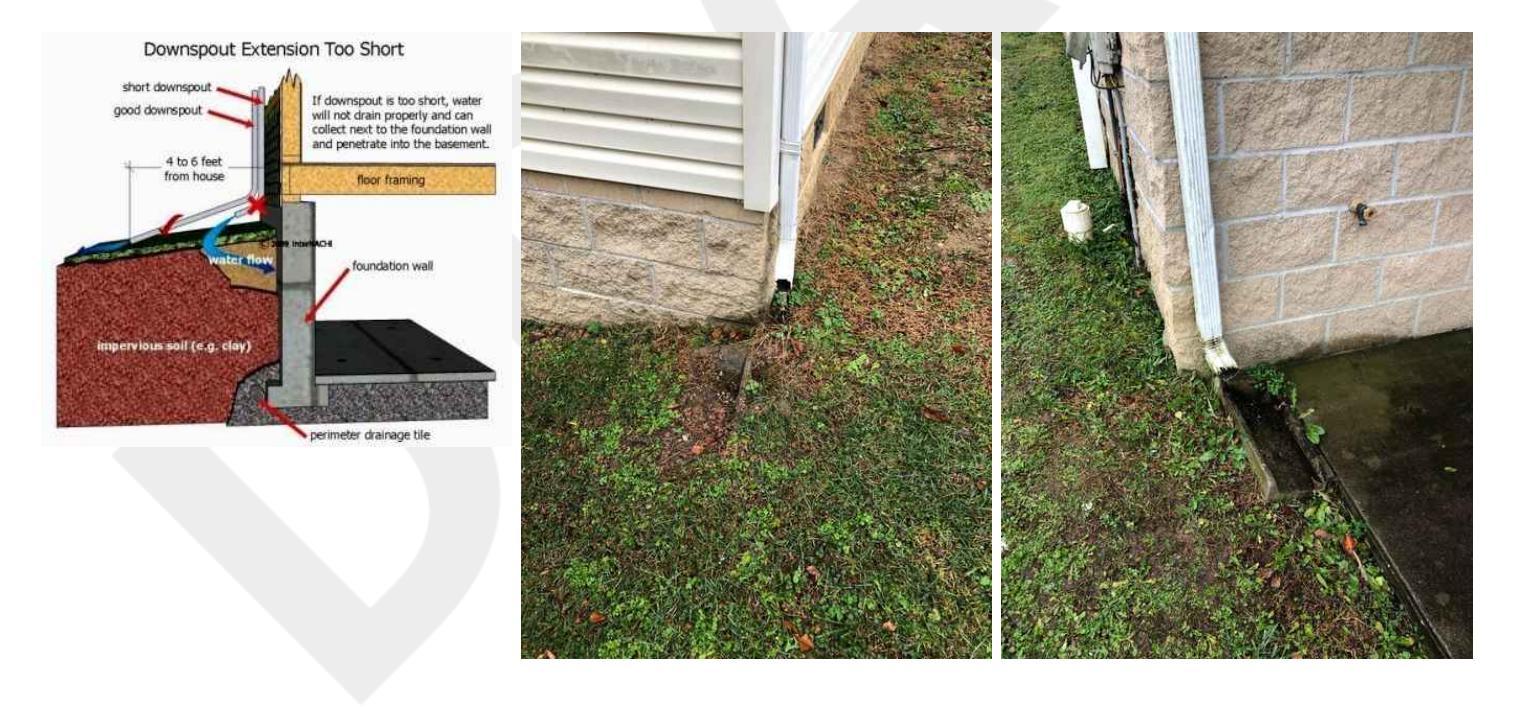
4.2.2 Roof Drainage Systems

GUTTER IMPROPERLY SLOPED

Recommend moving directional assist into correct position to eliminate drainage issue.

Recommendation Contact a qualified gutter contractor

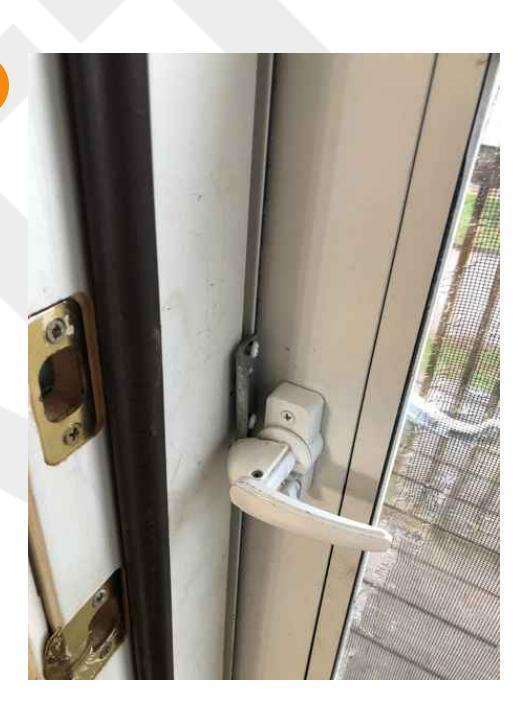
Rear exterior door latches but can easily be pulled open leading to more damage than is already present.

Recommendation Contact a qualified carpenter.

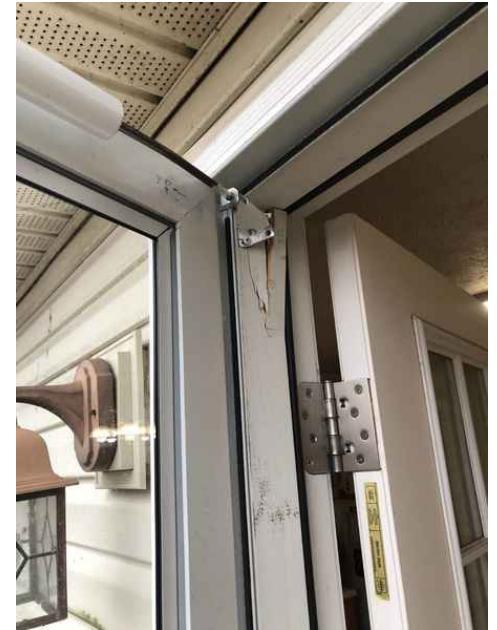
Rear exterior door closing device damaged by forceful opening likely by

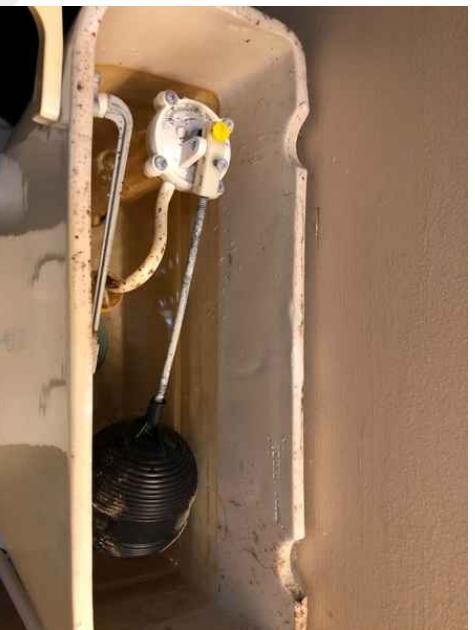
Water level in bowl is low, water level in tank is accurate.

Recommendation Contact a qualified plumbing contractor.

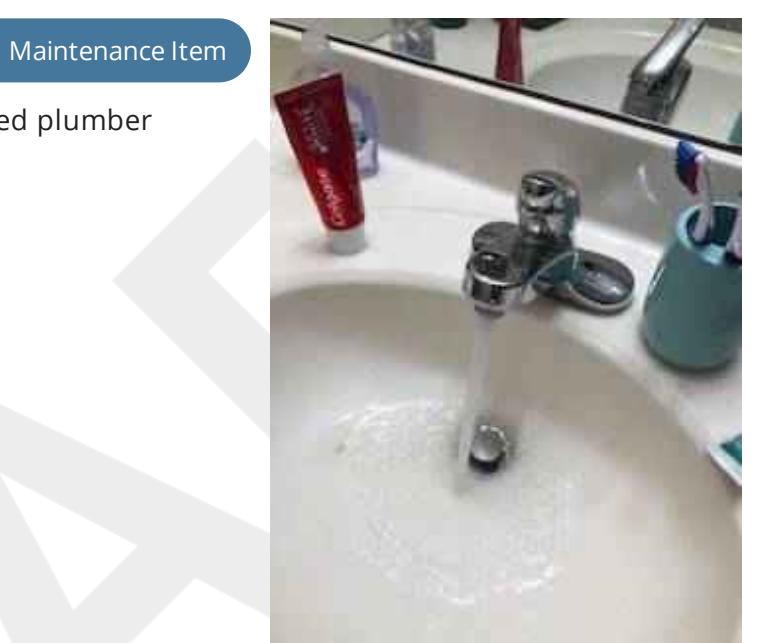
Hallway bath, hindered drainage

Contact a qualified plumbing contractor.

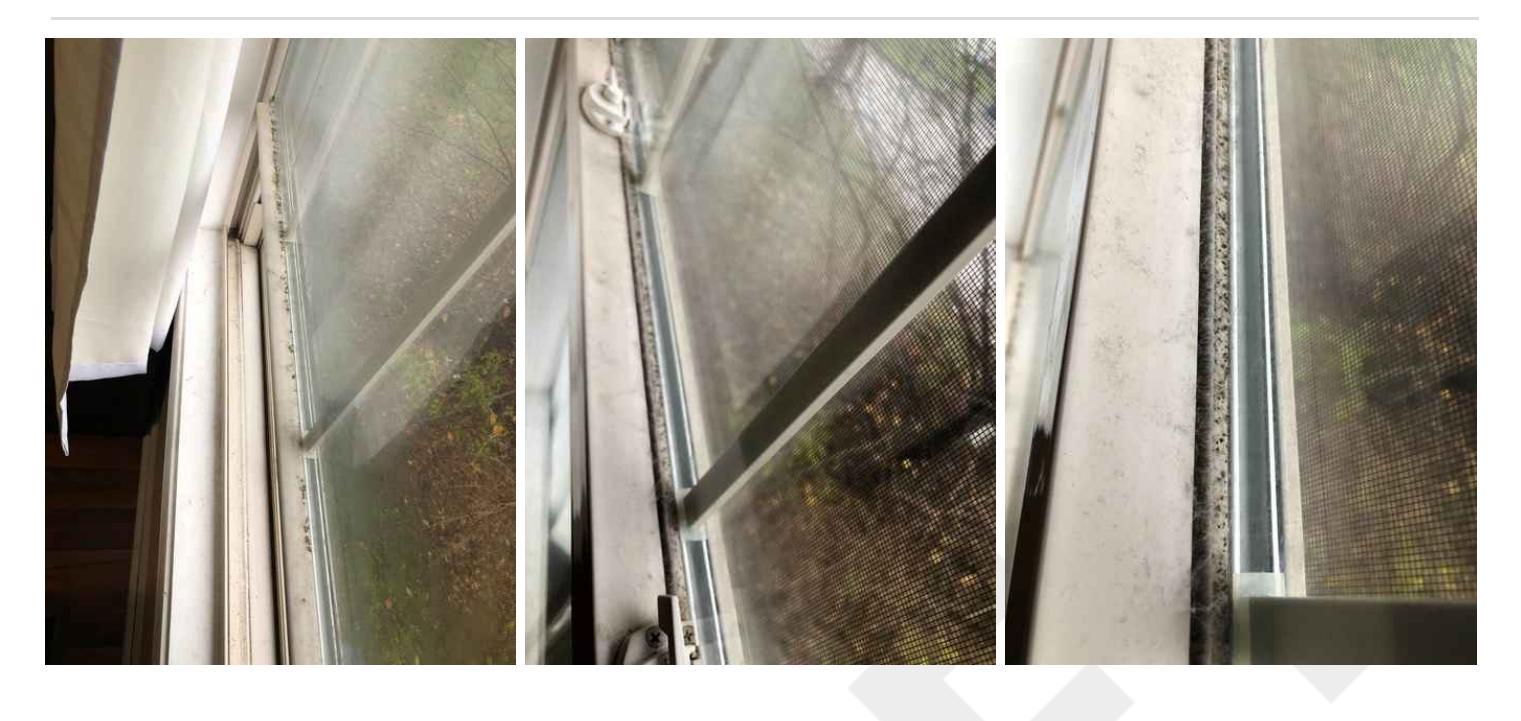
17.1.2 Environmental

PEST, RODENT EVIDENCE
