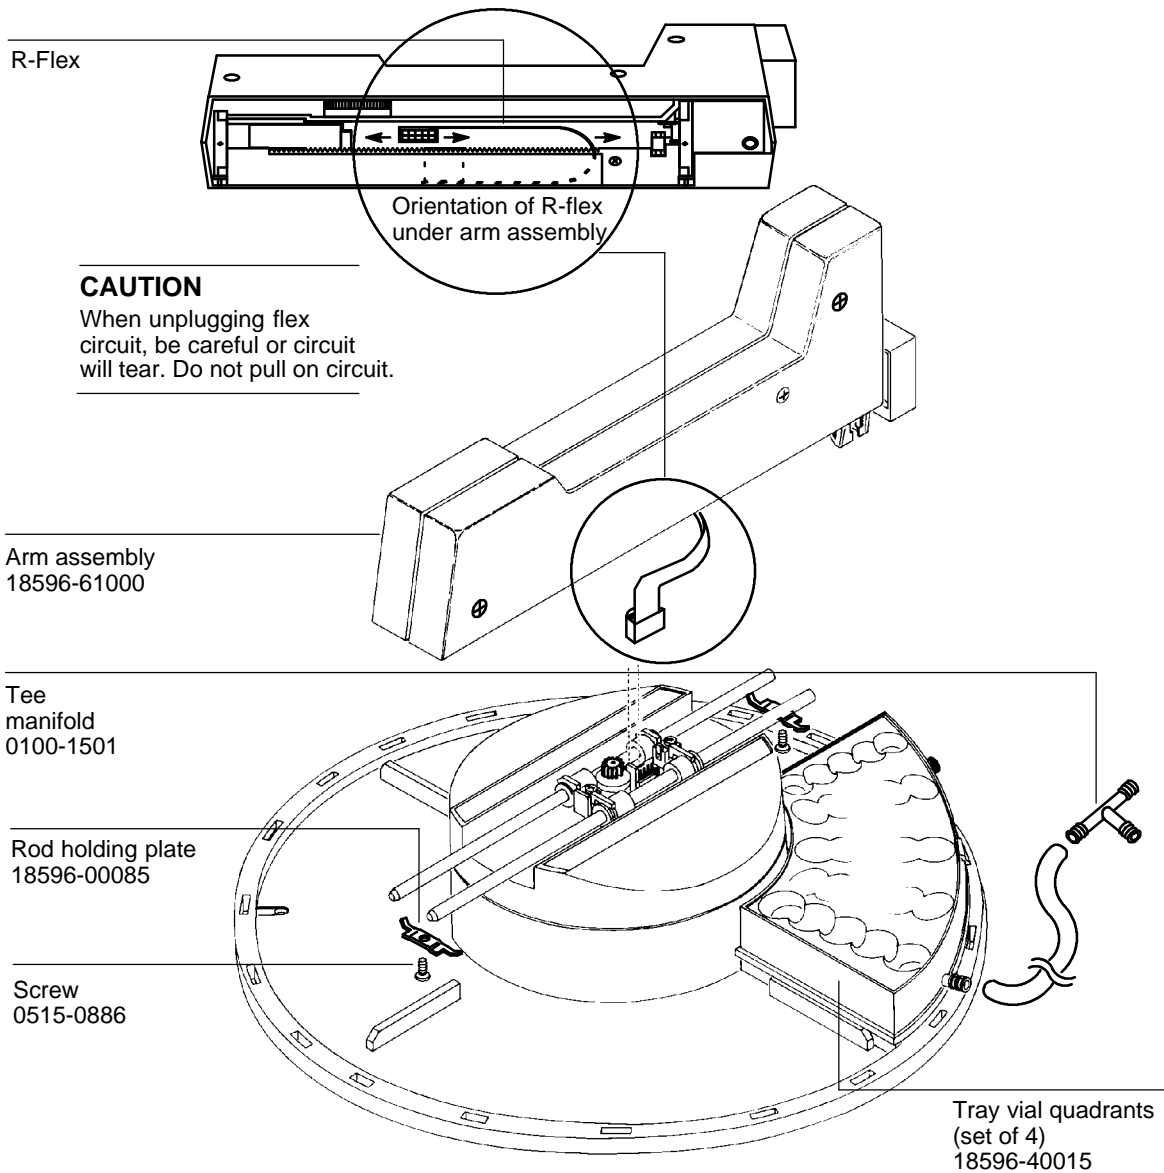
Figure 1030-8

Removing the tray arm assembly. See next page.

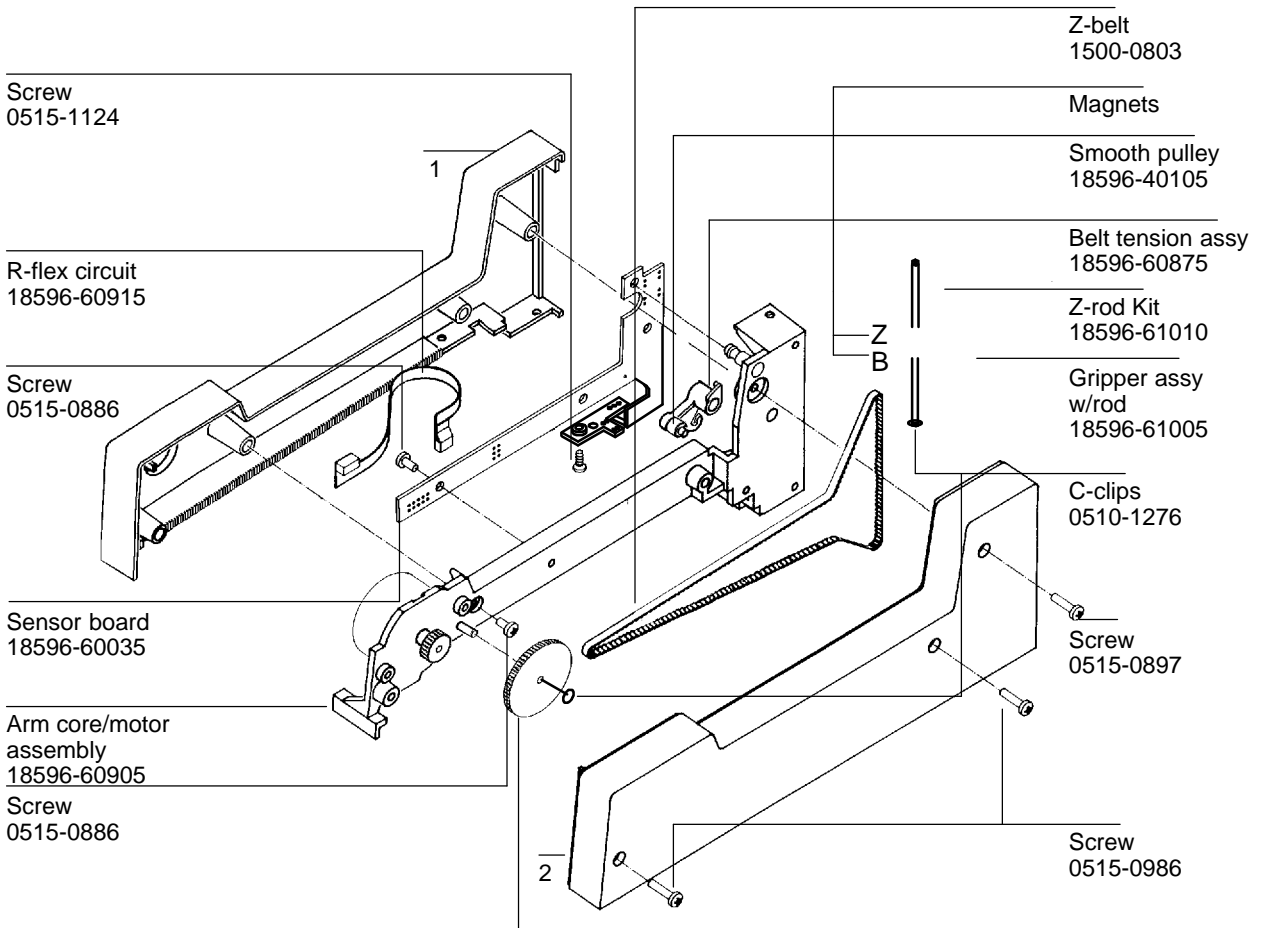
Figure 1030-9

Tray arm assembly (18596-60855)

Replaced by Matching Halves Kit 18596-60945:

- 1 Left arm half 18596-40045
- 2 Right arm half 18596-40055
